Geophysical Research Letters[®]

10.1029/2022GL101482

Close View of the Lightning Attachment Process Unveils the Streamer Zone Fine Structure

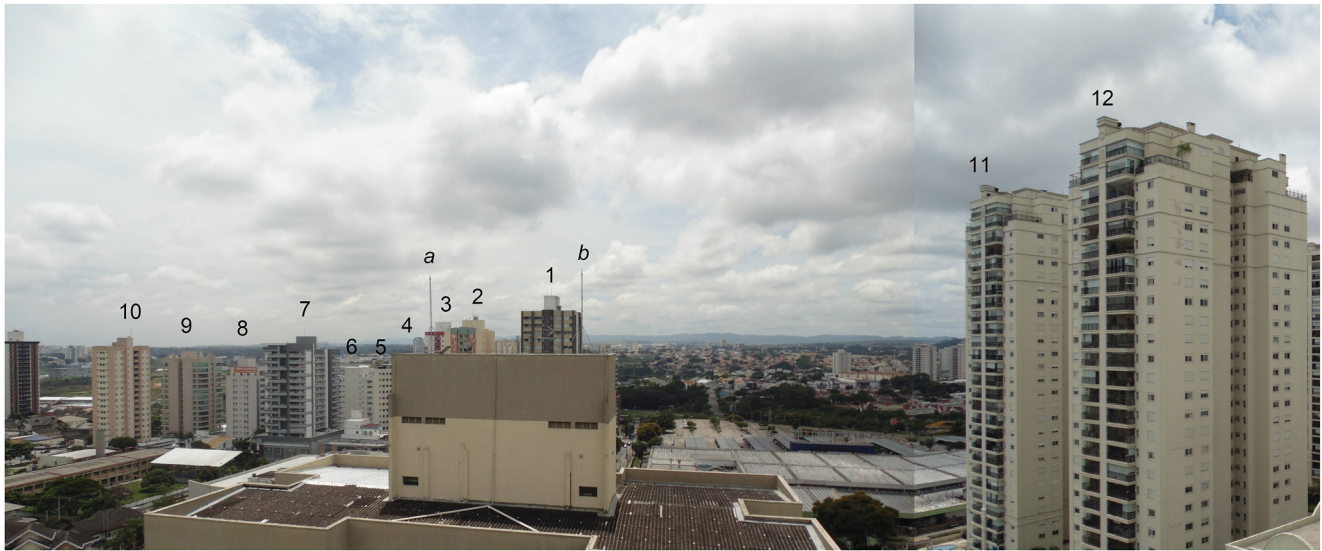
Figure 1. Buildings and structures observed by the camera installed in São José dos Campos, Brazil.

On 30 March 2021 a cloud-to-ground lightning flash containing five negative strokes made five different ground contacts. The negative leader of the second stroke started a different path to ground and connected to an UCL that was initiated on a chimney atop of a 27-story building, marked as building number **11** in Figure 1. The distance of the striking point to the camera was only 161 m and according to the lightning detection system, the peak return stroke current was -29.6 kA and occurred at 02:58:47.631051 UTC. Data from a 9-sensor lightning location system (LLS) were used to obtain the polarity, the time, and an estimate of the peak current of the return strokes observed. For the case analyzed in this work the location error of the LLS for the ground contact point of the flash observed was 188 m, which is considered very good. Further information about the LLS is provided by Morales et al. (2018).

Figure 2 shows some of the UULs initiated from buildings number **1**, **2**, **3**, **10**, **11**, **12**, and rods *a* and *b* in Figure 1. Remarkably this flash produced a staggering total of 31 upward leaders detected by our video cameras, only some of them appear in Figure 2 (images of other UULs are available in Supporting Information S1).

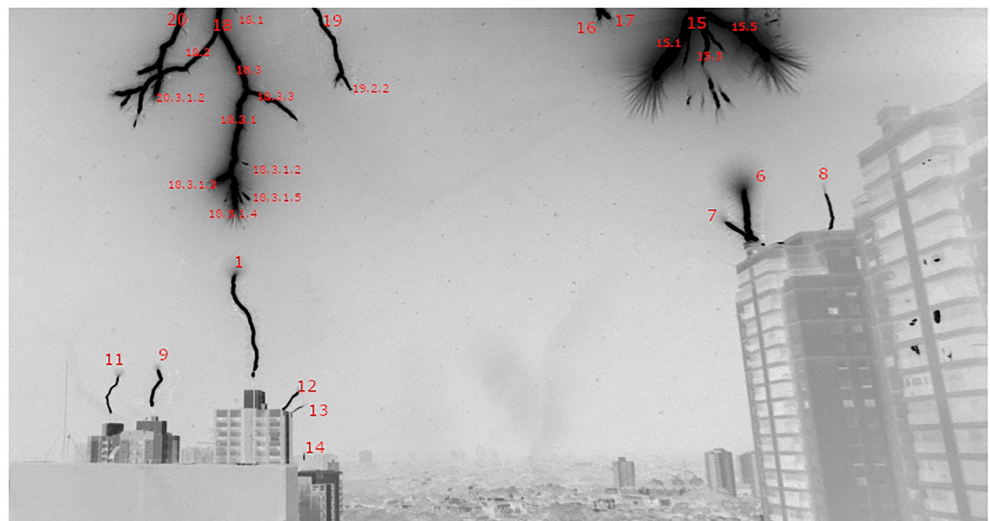
Figure 2. Lightning attachment to building 11. This figure shows one frame before the occurrence of the return stroke.

We manually analyzed 20 video frames preceding the lightning return stroke, spanning a 500 μ s interval. In order to track leader characteristics as a function of time, each frame of the video was marked and each leader was labeled, as shown in Figure 2. We use a decimal notation (with a “.”) to track branching in the negative leaders. Positive leaders do not require this effort as they do not branch. The attachment process happens when downward leader **15.5** connects to upward leader **6**.

Looking back into Figure 2, we can see that space stems appear in a number of other negative leaders, but (most importantly) not in all of them. For instance, we can see space stems in leaders **18.3.1.2** and **18.3.1.5**. This finding suggests that space stems are not a requirement for the negative leader propagation, but perhaps simply a

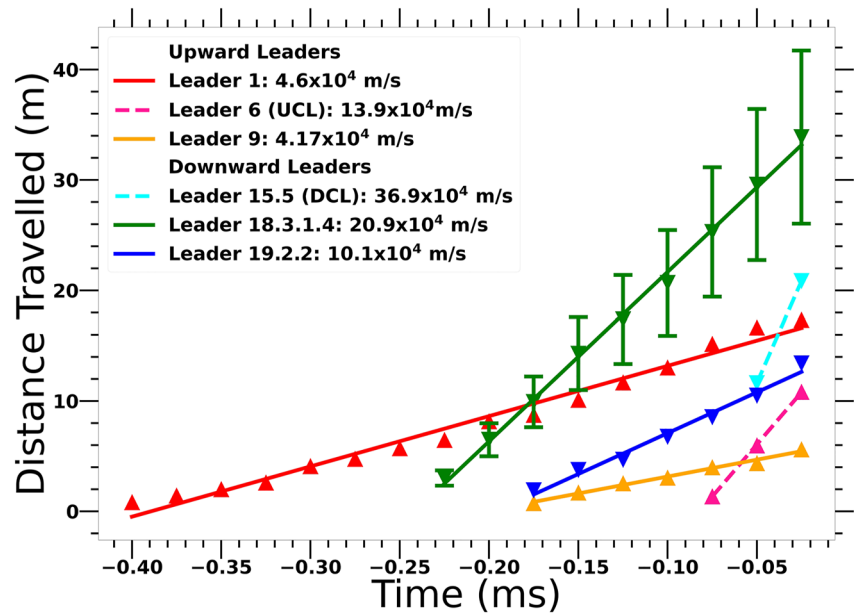
Figure 3. Distance traveled by some of the lightning leaders analyzed. The linear fit slope yields the leader average velocity, as listed in the figure legend. Upward and downward leaders are represented by upward- and downward-pointing triangles, respectively. Error bars are produced by propagating a ± 50 m horizontal location uncertainty into vertical position uncertainties. Upward connecting leader and downward connecting leader stand for the upward and downward connecting leaders, respectively.

Figure 3 shows the distance traveled by some of the leaders displayed in Figure 2. The slope in distance versus time gives the average leader speed within the video record. The UULs shown in Figure 3 have speeds of about 4×10^4 m/s, while the UCL is roughly 3 times faster, at 1.4×10^5 m/s. The UCL has a speed comparable to the average speed in the downward leaders, which is 1.2×10^5 m/s. The fastest downward leader is the downward connecting leader (downward connecting leader in Figure 3), which has a speed of 3.7×10^5 m/s. Statistical properties for the measured leader speeds are reported in Table 1. The values are comparable to what has been measured previously (Saba et al., 2017). The error in the determination of 2D distances was found to be within 20%–30%, and the coefficients of determination (R^2) of the linear fits used for speed calculation were higher than 0.96. The speed of negative leaders is tracked only for some dominant branches and from its root all the way down to its lowest point. For example, the position of leader 18.3.1.4 (on the left-hand side in Figure 2) is tracked all the way back to the top, when it emerges in the frame and is labeled as leader 18.
